Canton Police Station Reno  
Project No.: 2023-001-01  
Issue to: Bidders

Town of Canton, Owner  
Contract Document Date: July 07, 2025  
Addendum Date: March 31, 2026

# CANTON, NC MUNICIPAL PROJECT - ENVIRONMENTAL SERVICES

CANTON, NC SITE

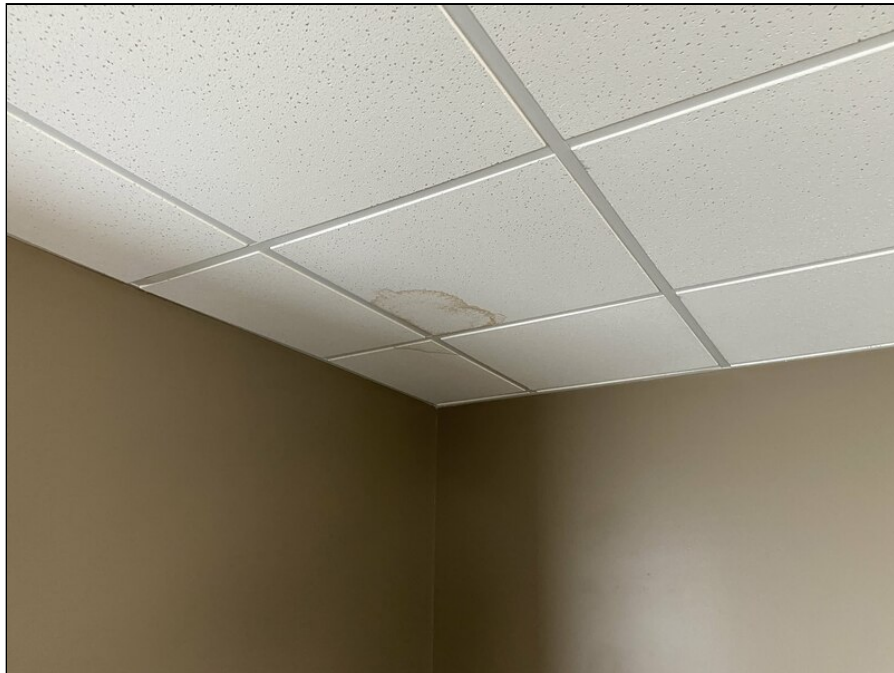
- Visible water staining on ceiling tiles throughout the first and second floors;
- Visible water damage on concrete flooring and walls in the basement; and,
- Musty smell in basement.

2 - View water stained ceiling tiles

- Hire a certified roofer and/or HVAC technician to identify cause of water stained ceiling tiles.
- Hire a structural engineer to identify the cause of the water intrusion in the basement.
- Removal of all water damaged ceiling tiles.
- Remediation of the basement, which will include:
  - General cleaning of the basement and its contents utilizing a high efficiency particulate air (HEPA) filtered vacuums and wet wiping using an EPA approved disinfectant.
  - Running negative air machine's during cleaning and for approximately 24-48 hours after cleaning.
  - Final clearance air sampling after remediation is complete is recommended.

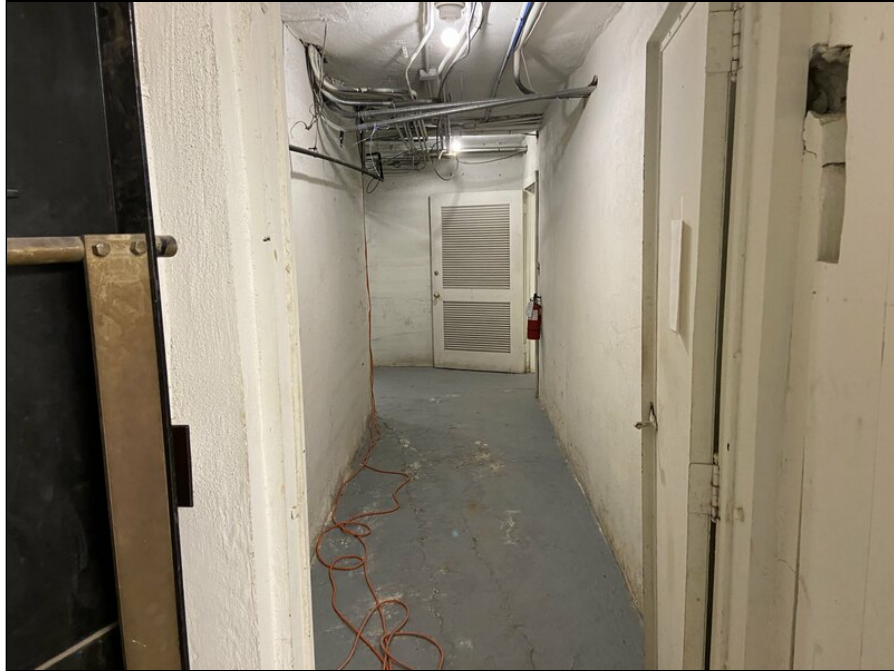
3 - View of basement

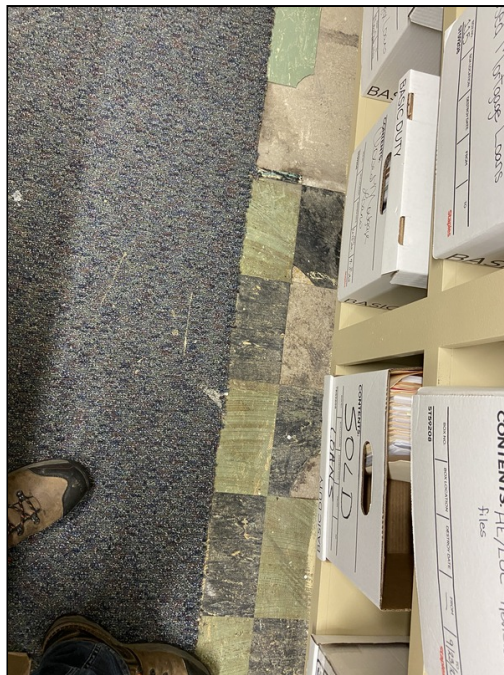
4 - View of asbestos-containing black floor tile

ECS recommends where a material type has been identified as asbestos-containing that other materials with similar color, texture, age and size throughout the building's interior and exterior be assumed to contain asbestos. Please refer to Section 4.1 for a complete list of building materials that were reported positive for asbestos and to Section 4.2 for materials that were assumed to contain asbestos. ACMs should be removed prior to disturbance.

If ACMs are to be removed, it is recommended that an industrial hygienist monitor the project. This involves collecting air samples from within and outside abatement work areas to monitor the asbestos abatement contractor's work practices over the course of the project. The industrial hygienist should evaluate if the asbestos abatement work is in accordance with project specifications, U.S. EPA regulation 40 CFR Part 61-National Emission Standards for Hazardous Air Pollutants Subpart M: National Emission Standard for Asbestos, and U.S. Occupational Safety and Health Administration (OSHA) regulation 29 CFR 1926.1101 – Asbestos in Construction. The industrial hygienist should assess each work area to monitor the removal of ACMs. Only after the industrial hygienist has determined the identified ACMs have been removed should final clearance air samples be collected (if necessary).

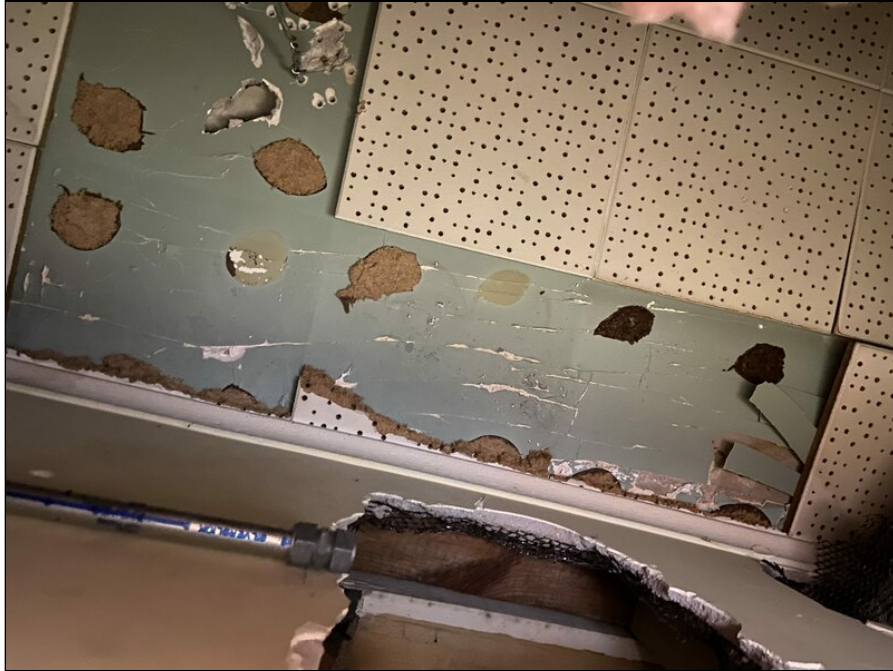
7 - View of original ceiling tiles above drop-down ceiling

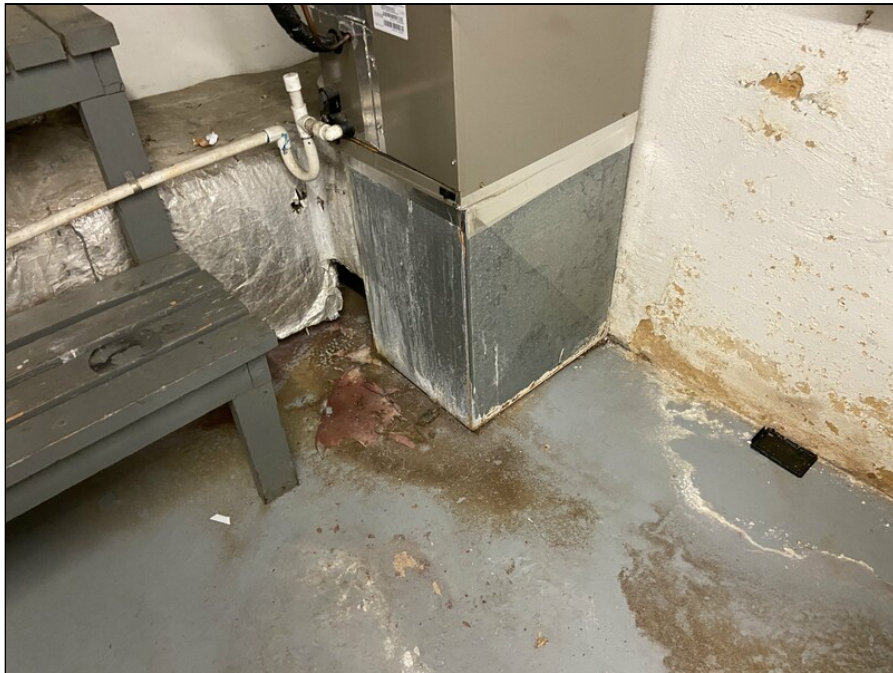
8 - View of water damage on basement floor
