Canton Town Hall Reno  
Project No.: 2023-001-02  
Issue to: Bidders

Town of Canton, Owner  
Contract Document Date: July 07, 2025  
Addendum Date: March 31, 2026

# CANTON, NC MUNICIPAL PROJECT - ENVIRONMENTAL SERVICES

128 ACADEMY STREET  
CANTON, NORTH CAROLINA 28716

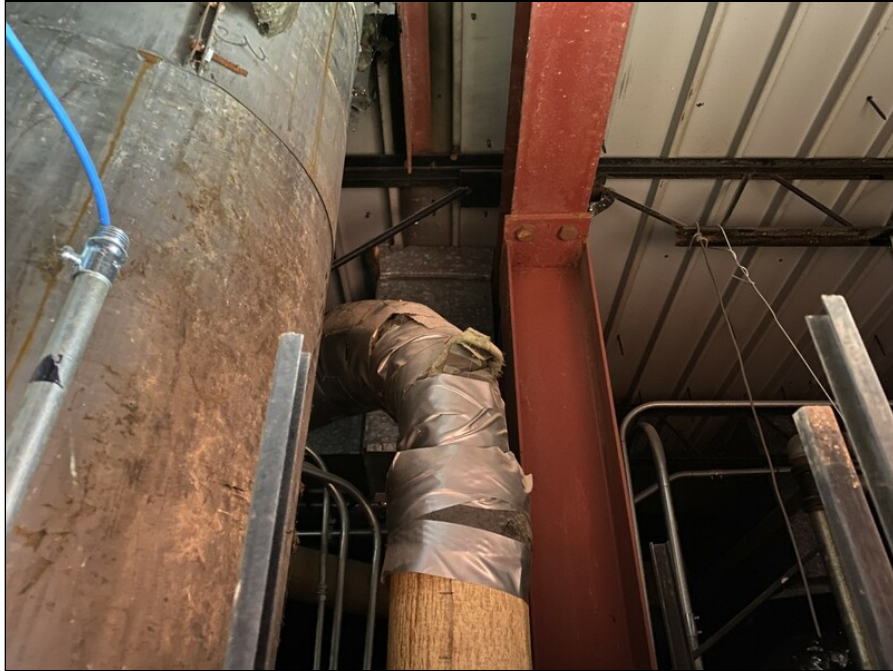
7 - View of fiberglass piping.

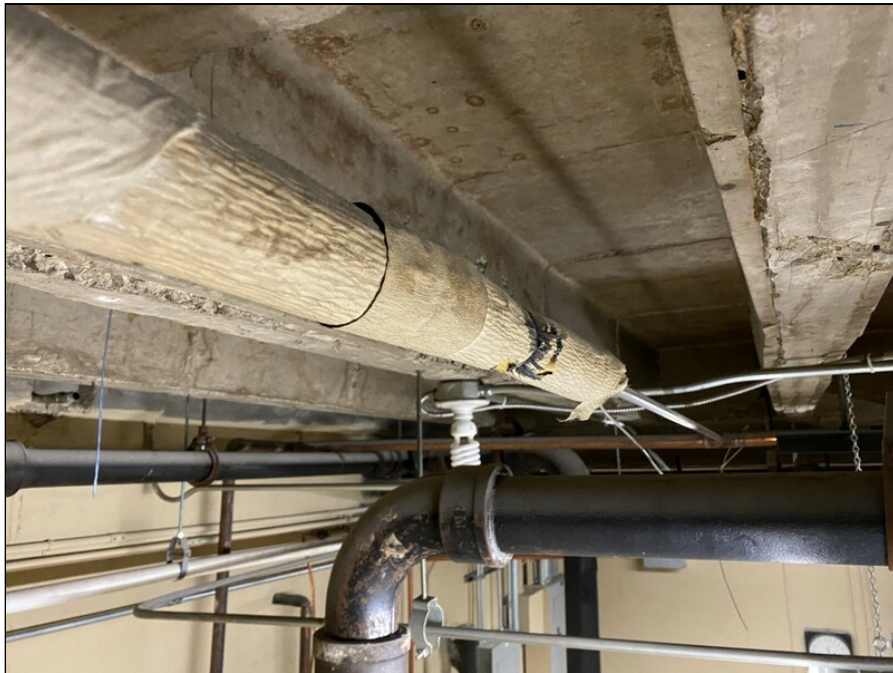
8 - View of fiberglass piping, with ACM white mudded fittings.

ECS recommends that ACMs are abated prior to demolition activities that may disturb them. ECS recommends where a material type has been identified as asbestos-containing that other materials with similar color, texture, age and size throughout the building's interior and exterior be assumed to contain asbestos. Please refer to Section 4.1 for a complete list of building materials that were reported positive for asbestos and to Section 4.2 for materials that were assumed to contain asbestos. ACMs should be removed prior to disturbance.
